**AUDITOR CERTIFICATION
REPORT & STATEMENT OF
REASONS: PROSERPINE FIRE
STATION, 102 MAIN STREET,
PROSERPINE, QLD
QUEENSLAND FIRE AND EMERGENCY
SERVICES**

19 FEBRUARY 2020
719052
VERSION 1

**Auditor certification report and statement of reasons: Detailed site investigation (DSI)
for Proserpine Fire Station, 102 Main Street, Proserpine, Queensland**

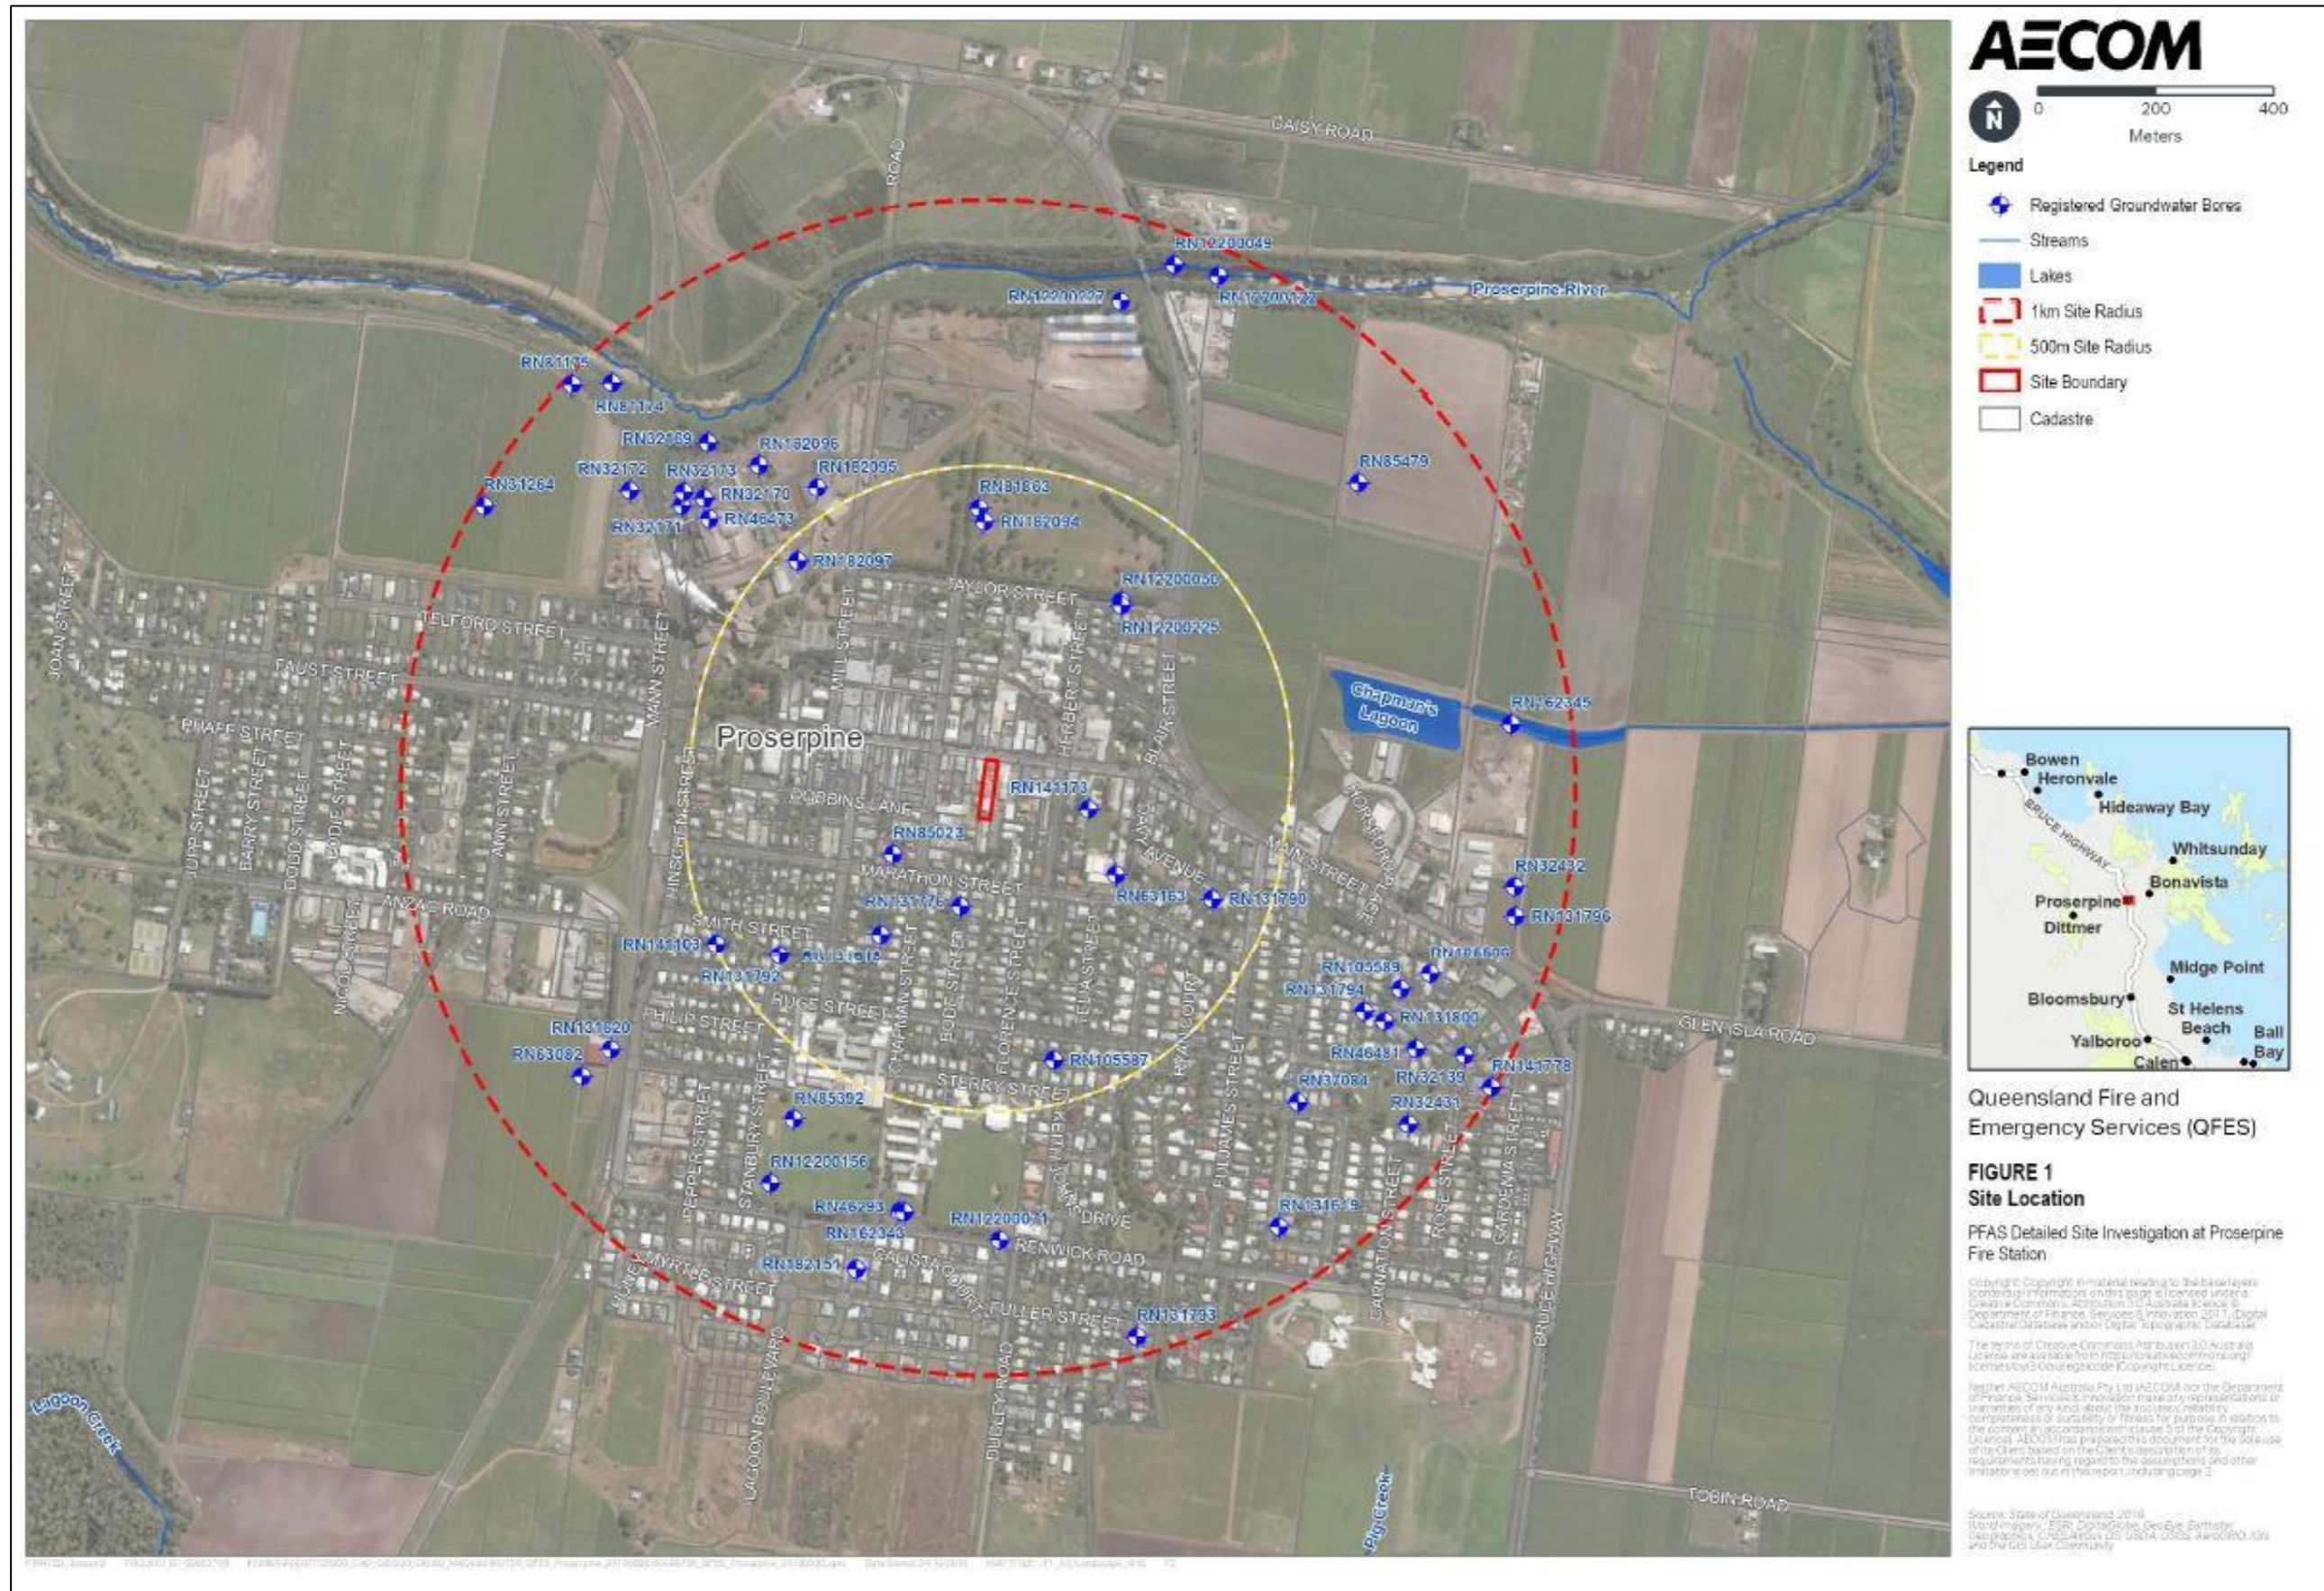
Figure 1: Site location Plan (reproduced from AECOM 2019b)

- **North:** Main Street with commercial businesses beyond. The Proserpine Sugar Mill (Wilmar Sugar) is located approximately 350 m to the north of the site with the Proserpine River at a distance of approximately 850 m (see **Figure 1**).
- **East:** A commercial/ industrial business (Ford Car dealership) including administration/ display show room buildings and outdoor hardstand parking/ viewing areas is located adjacent to the site, to the east. Additional commercial properties and some residential dwellings are located beyond. A service station is located ~270 m to the east.
- **South:** Commercial/ industrial properties are located adjacent to the site, to the south and south-west (Proserpine Ex Servicemans Club). Residential properties are located to the south (east, south-east to south-west) at a range of 30-90 m .

Queensland Globe (DNRM,2020) was used by the Auditor and AECOM (2019b) to search registered bores in the vicinity of the site. The database indicated that there are a total of 47 registered groundwater bores within a 1 km radius of the site (refer **Figure 1**); with 14 of these bores located within 500 m of the site boundary. At least seven of the bores within 500 m of the site are registered for “water supply” use, although the type of water supply (e.g. irrigation, stock watering or potable use is not known).

3.	Figures	Figure 1	<ul style="list-style-type: none"> • Bore RN162365 does not appear to be shown on Figure 1. • RN162343 (bottom) and RN12200225 (centre, top), are missing registered bore symbols, (although it is noted these locations may be difficult to who, in the vicinity of other nearby wells, at this resolution, please check and amend as necessary. • Please check symbol to the left of RN131800 (right side of diagram) – this symbol appears to be missing a label. • Given accompanying Table 4 presents data for those registered bores within 500 m of the site, it may be beneficial to add a “500 m site radius” to the Figure.

24.	3.5	Hydrogeology	<ul style="list-style-type: none"> Paragraph 1 – the inferred groundwater flow direction specified here is to the north. This is inconsistent with flow directions identified in other sections of the report (executive summary, conclusions, Section 6.2.2). Please check and amend as necessary. If this is to indicate differences in regional groundwater flow direction and localised flow directions, please provide clarification to this effect. It is noted paragraph 2 indicates 13 bores are located within 500 m of the site. However, only 12 are presented in Table 4. Please check and amend as necessary – it may be that RN105587 is missing from Table 4. RN131618 appears to be missing from Figure 1 – please check and amend as necessary.

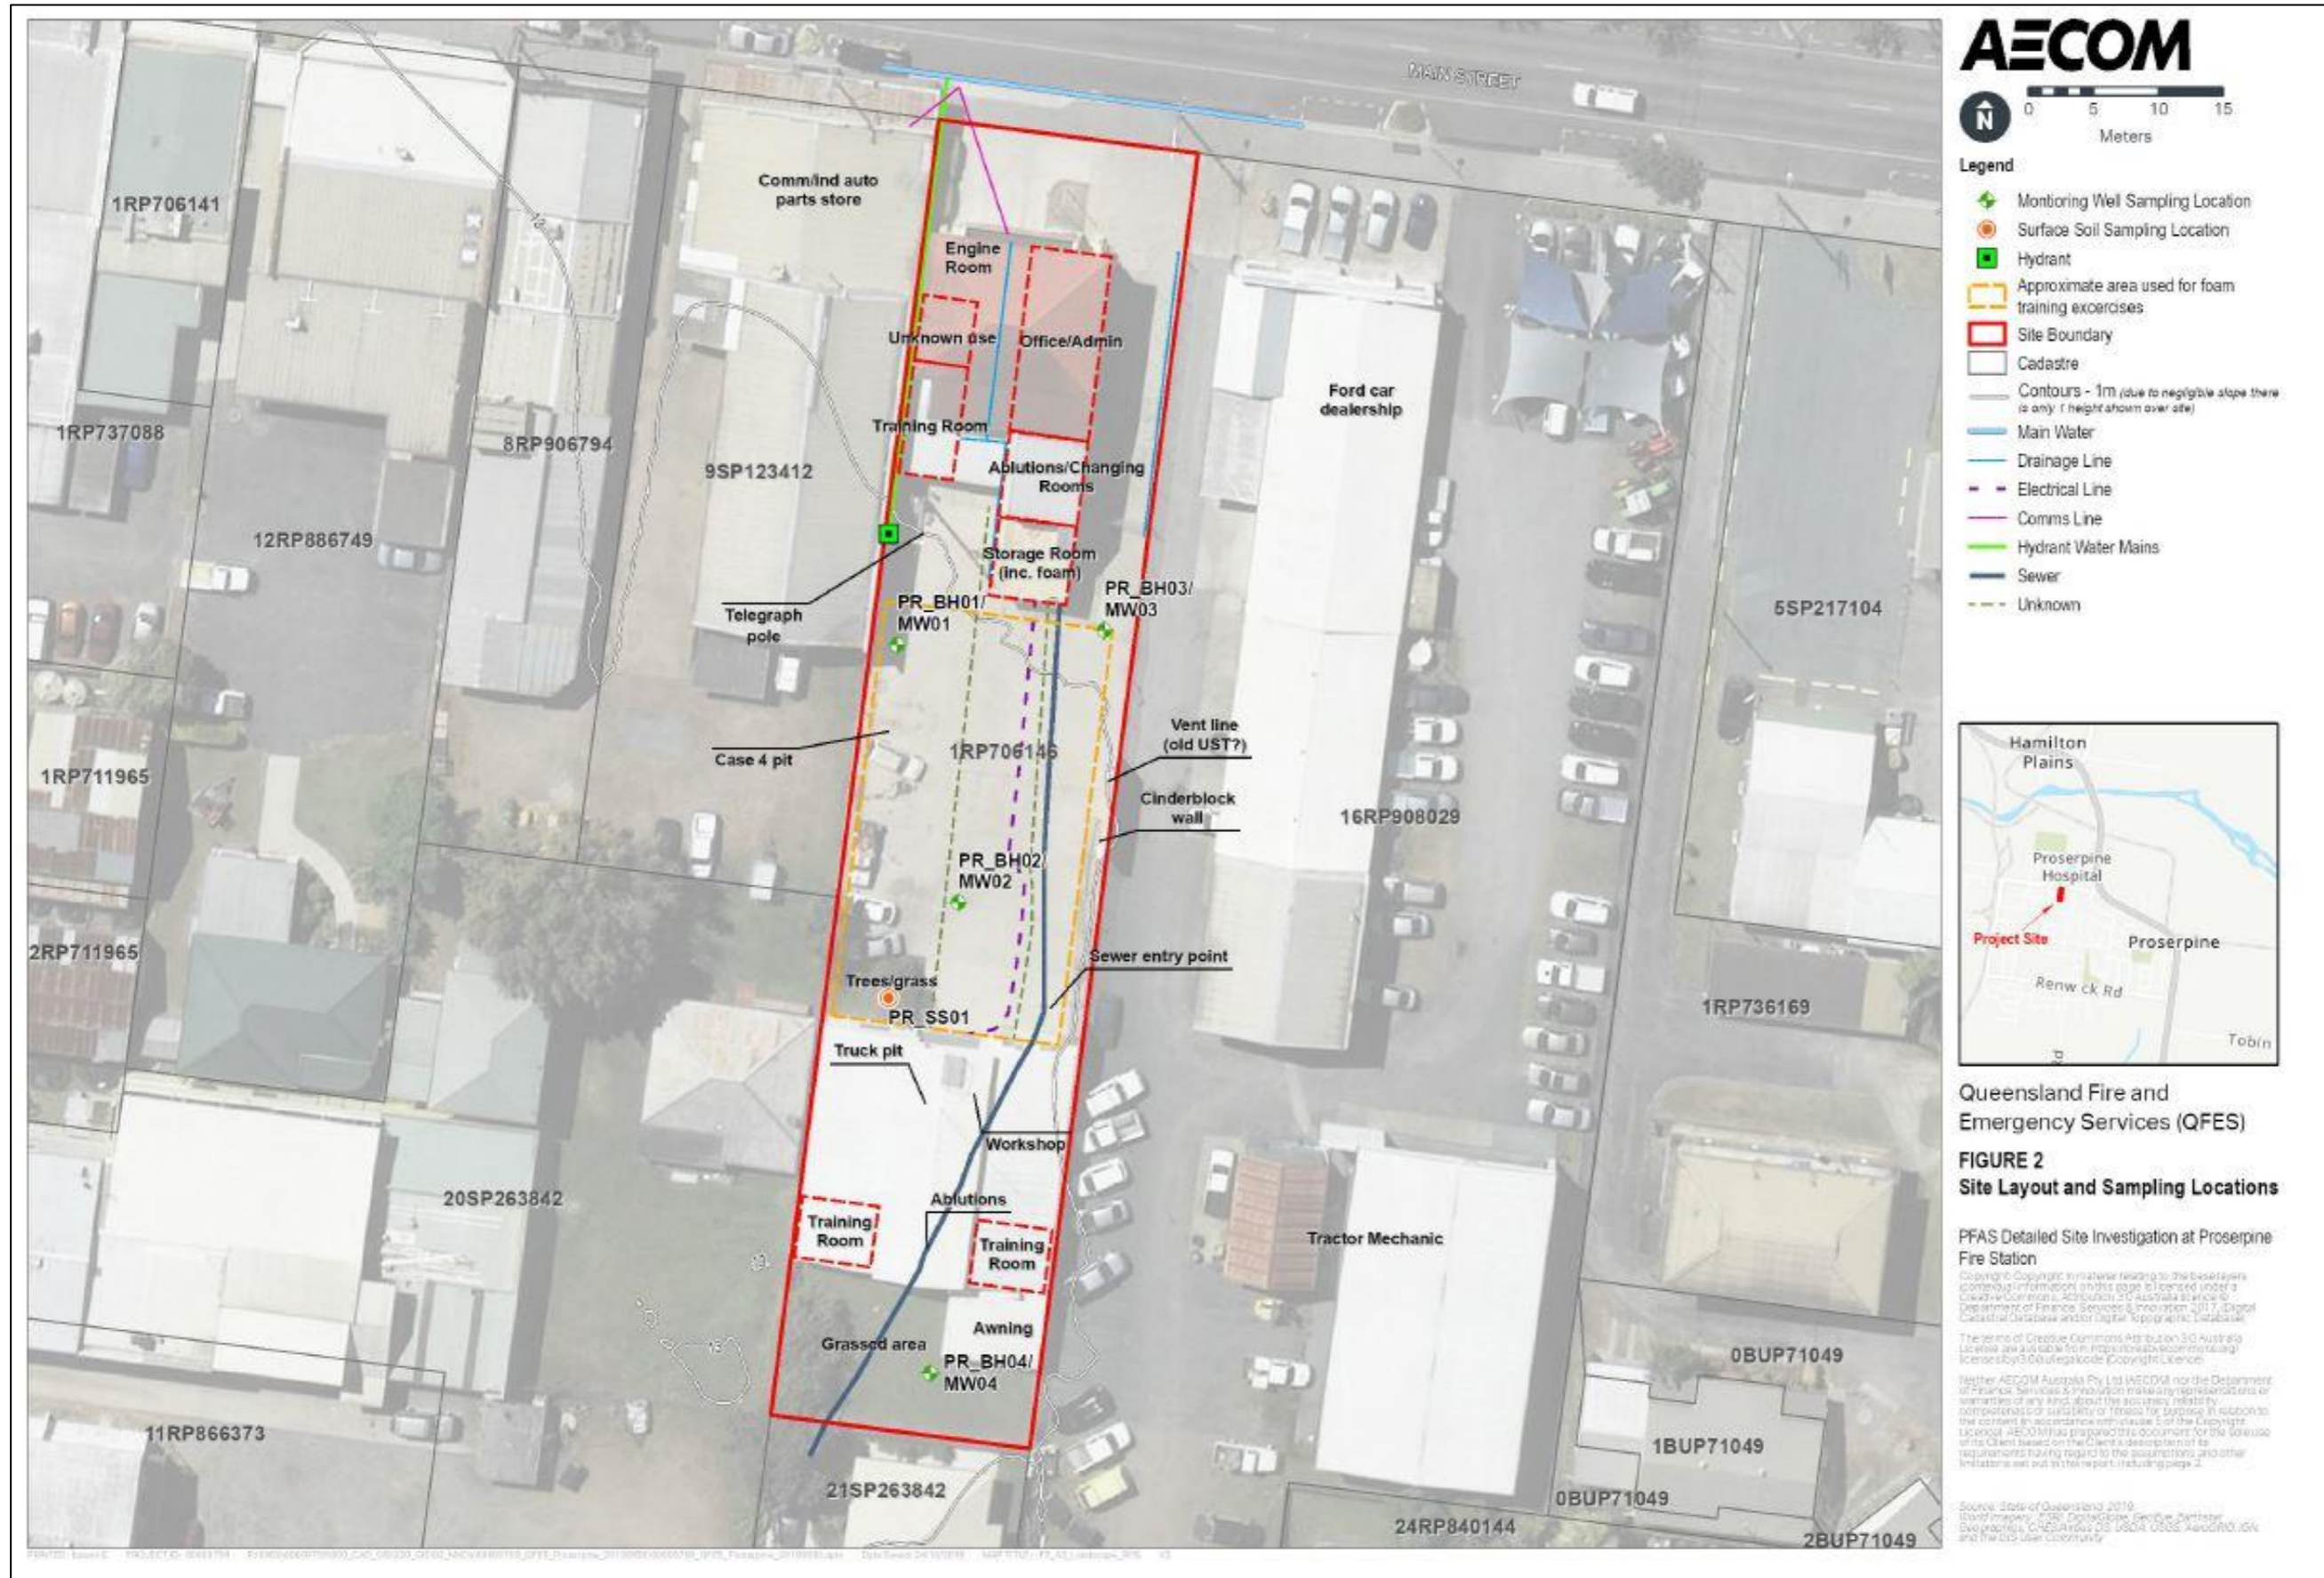
Figure 2: Site layout and sampling locations (reproduced from AECOM 2019b)

A vent line, possibly indicative of an existing underground fuel storage tank (UST) was observed adjacent to the eastern boundary of the site (refer **Figure 2**). However, it is understood that no evidence of an existing *in-situ* UST was identified during the ground penetrating radar (GPR) survey undertaken during site investigation service clearance.
