**AUDITOR CERTIFICATION
REPORT & STATEMENT OF
REASONS: AIRLIE BEACH FIRE
STATION, 2495 SHUTE HARBOUR
ROAD, MANDALAY, QLD
QUEENSLAND FIRE AND EMERGENCY
SERVICES**

4 MARCH 2020
719052 AIRLIE BEACH
VERSION 1

**Auditor Certification and Statement of Reasons: Detailed Site Investigation (DSI) of
Airlie Beach Fire Station, 2495 Shute Harbour Road, Mandalay, Queensland**

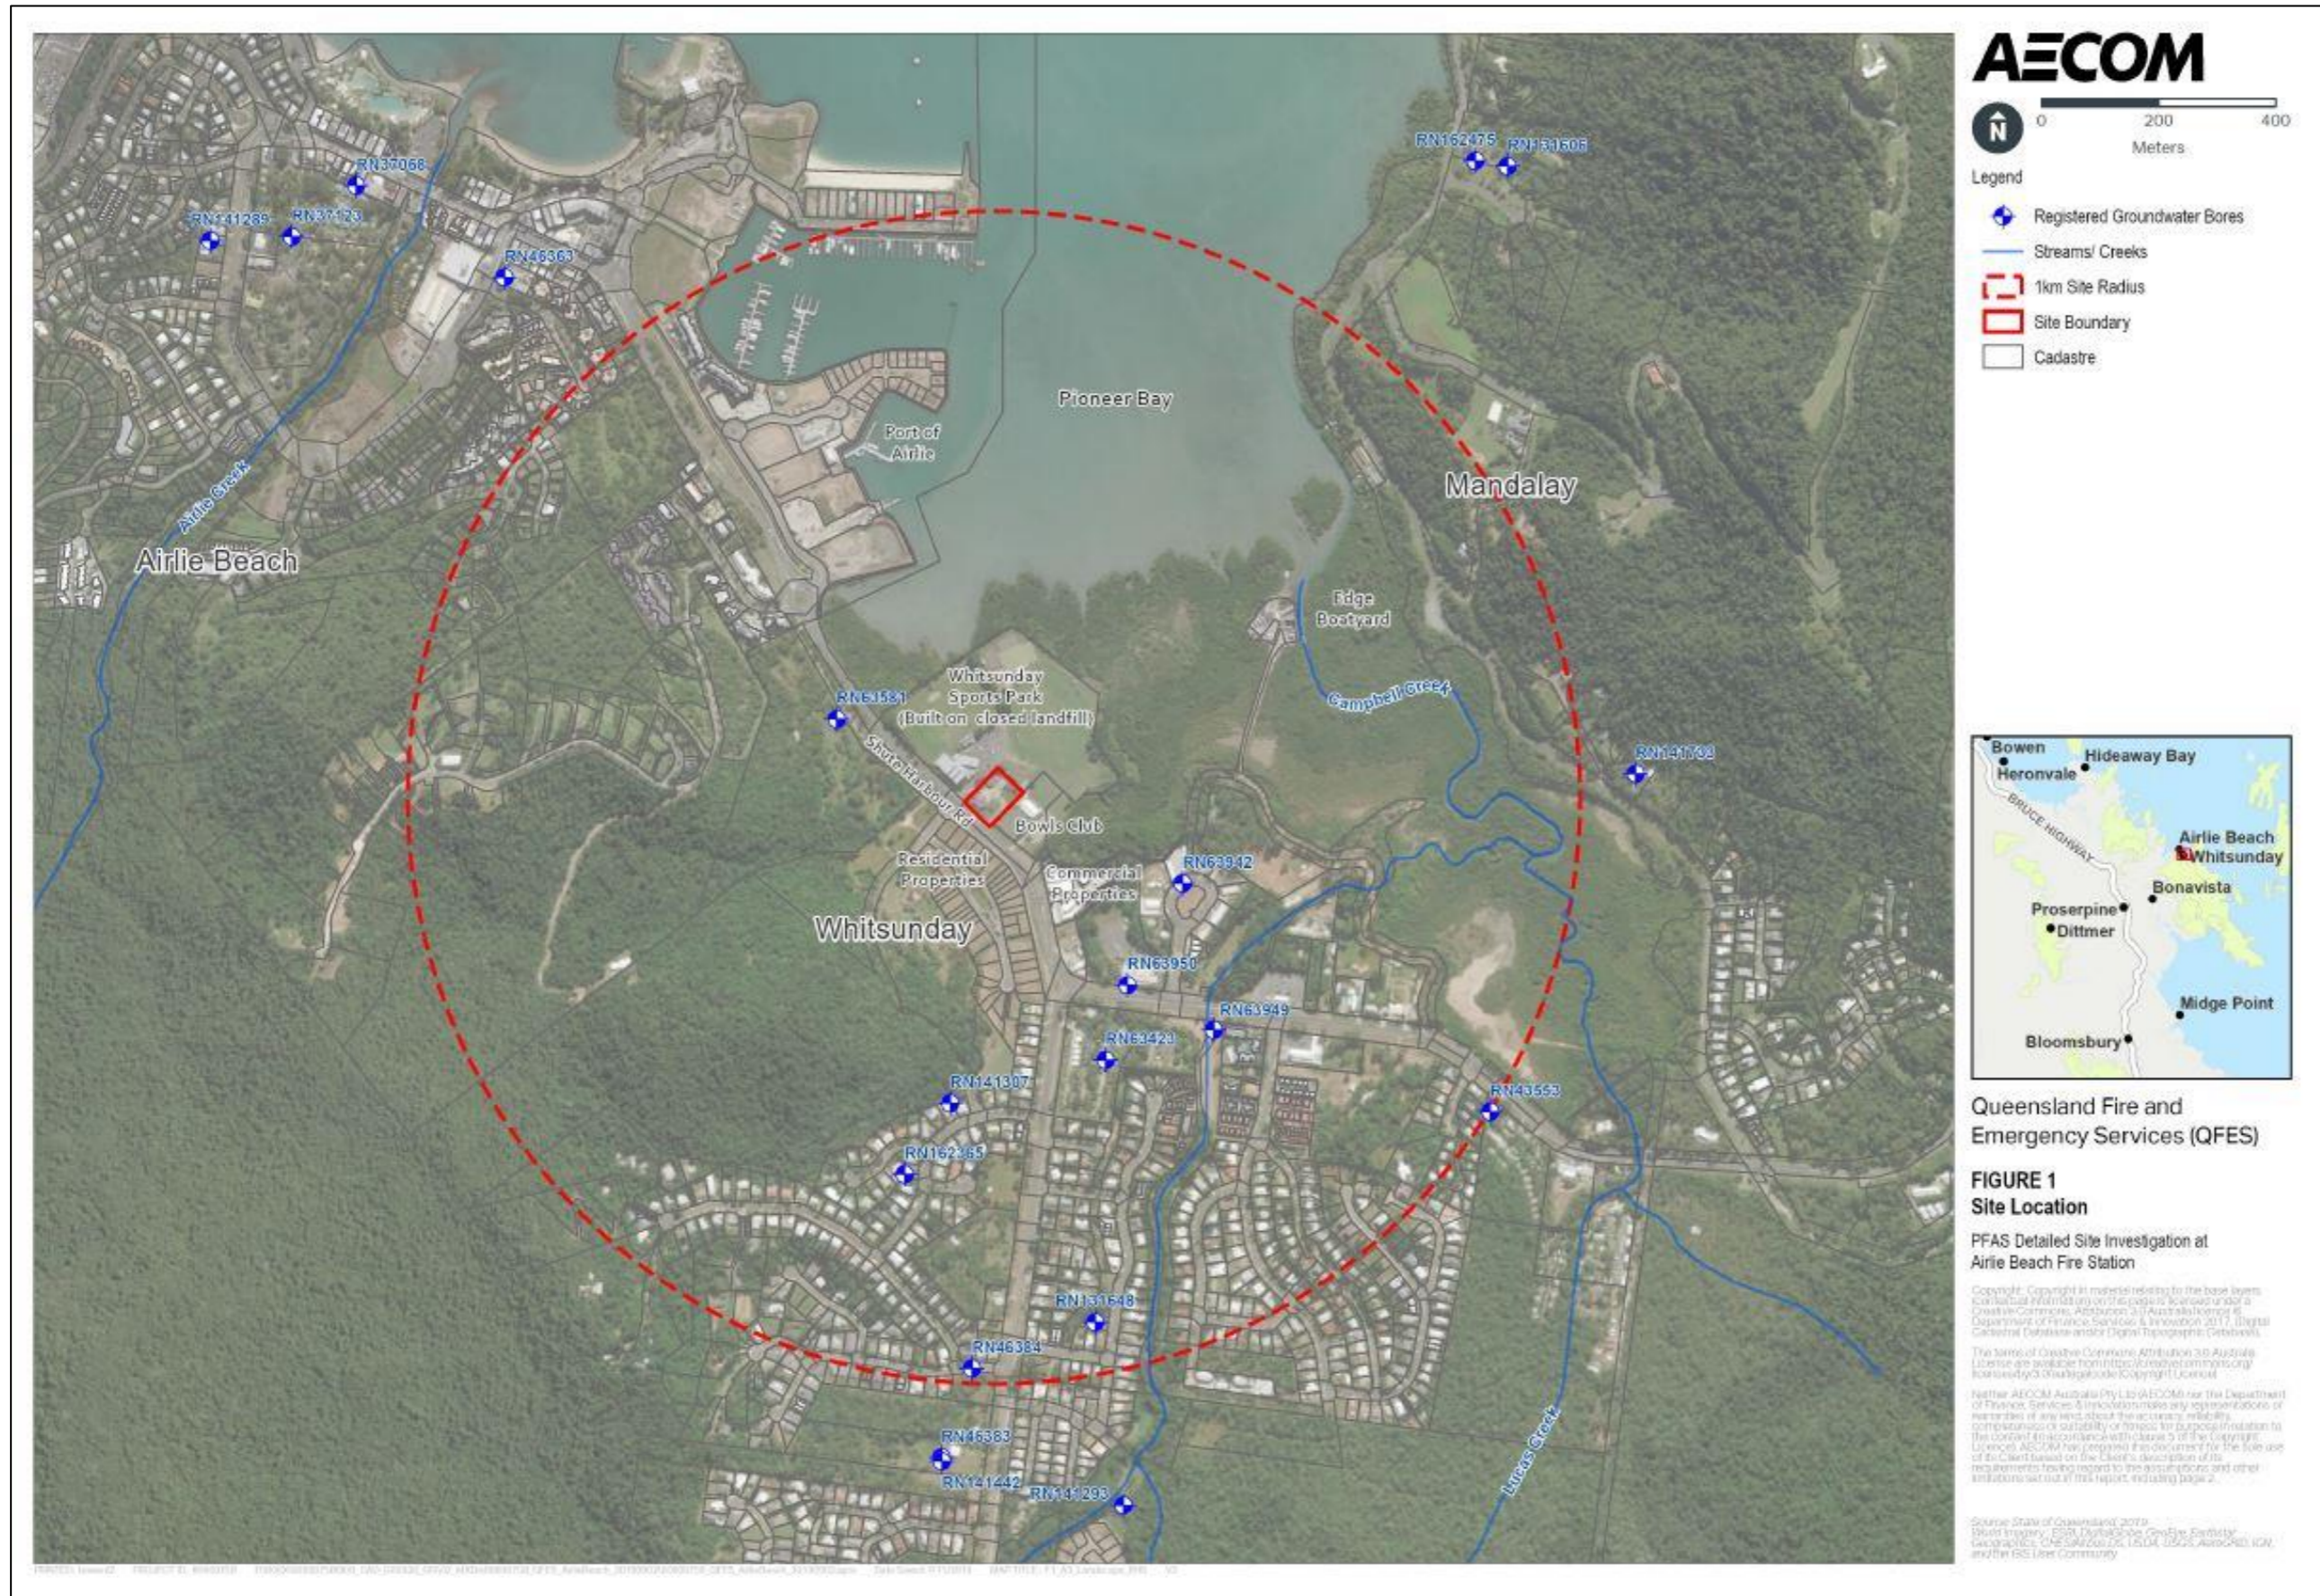
Figure 1: Site location plan (reproduced from AECOM 2019b)

The regional locality of the site is provided on **Figure 1** and site identification details provided in **Table 1**. The subject property lot and site layout are provided on **Figures 1 and 2**.

Queensland Globe (DNRW,2020) was used by the Auditor and AECOM (2019b) to search for registered bores in the vicinity of the site. The database indicated that there are a total of 10 bores within a 1 km radius of the site (refer **Figure 1**), four of which are located within 500 m of the site boundary.

See **Figure 1** for these features.
